Survival Factors and Biomechanics Factual Report In support of the General Aviation Airbag Study

November 16, 2009

Location: Stigler, OK
Aircraft Type: Cessna 182T
Accident Date: 4/9/2009
Accident Time: 2115Z
Accident Number: CEN09LA247
Airbag Equipped: ☒

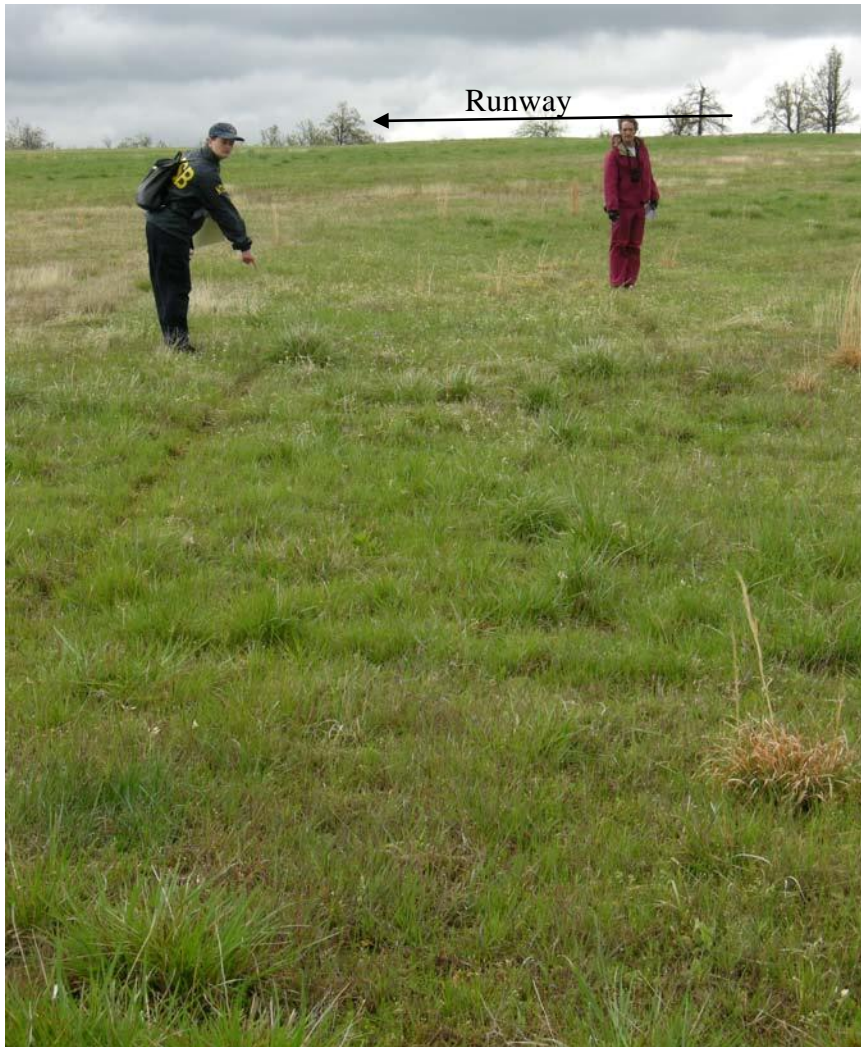
Figure 1: A photograph showing the first ground marks off the left side from the runway. (The runway runs approximately along the crest of the hill in the background of the photograph.)

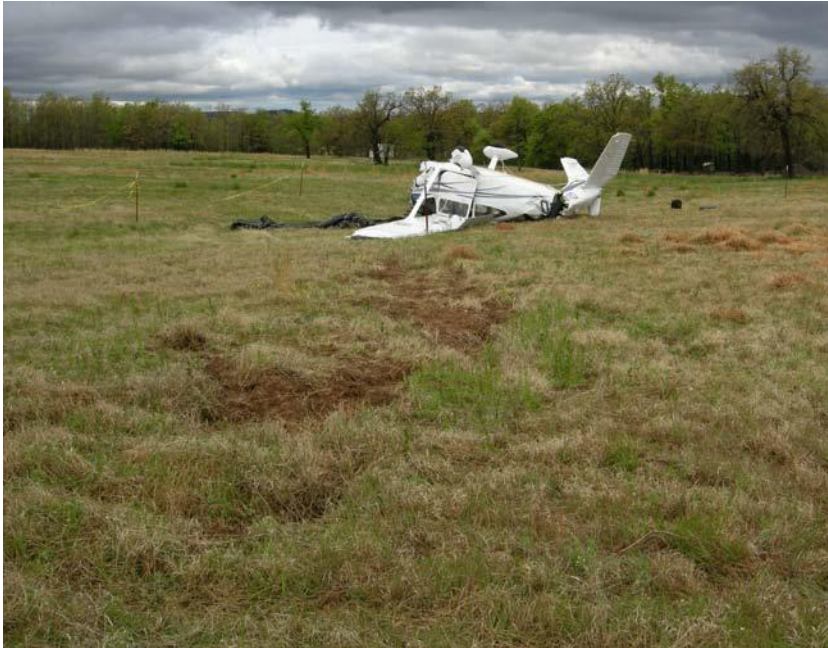
Figure 2: The aircraft was inverted at final rest with the tail twisted and broken and the nose and engine thrown past the final rest position. In the foreground, the two major impacts of the nose into the ground can be seen.

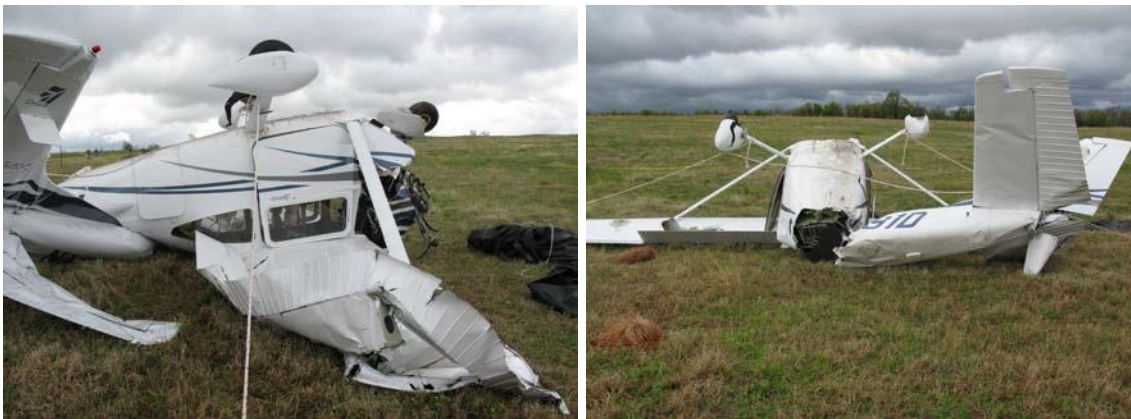
Figure 3: Photographs of the plane at final rest.

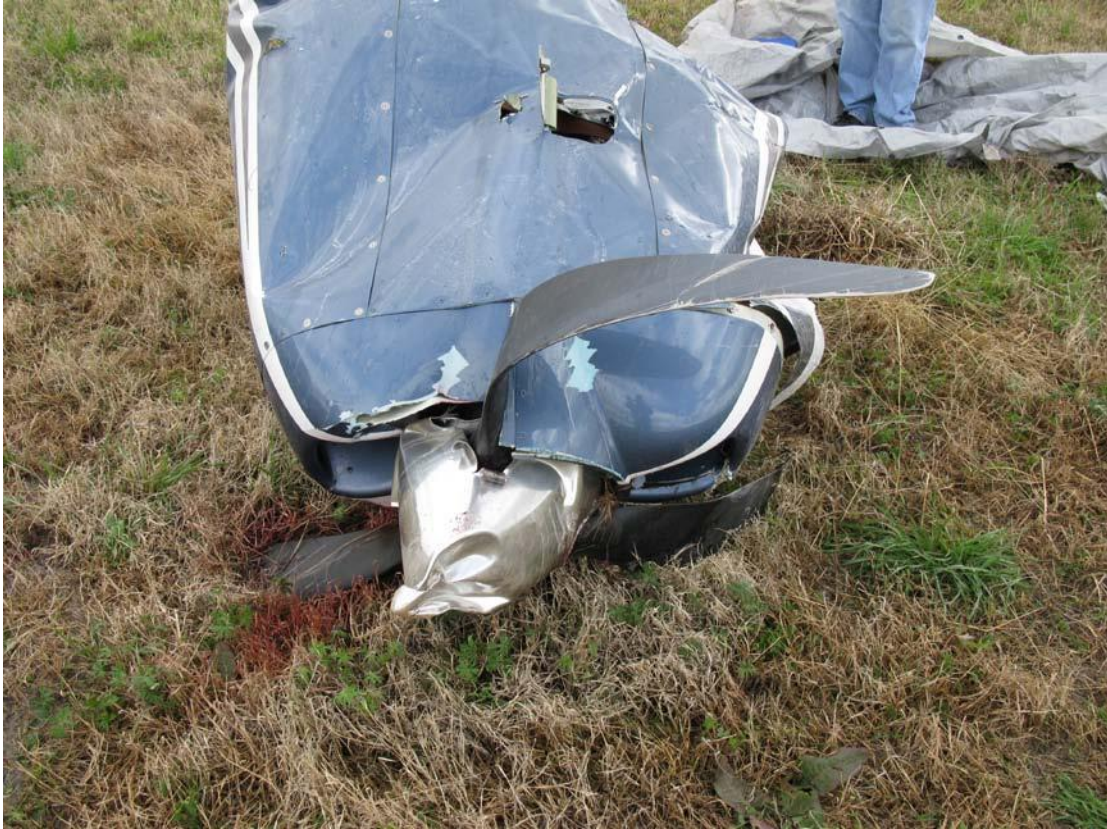
The primary impact to the airplane was on the underside of the aircraft's nose. (See Figure 4.) The engine separated from the aircraft and was found approximately 30' past the aircraft's final rest position. The primary impact direction was from the bottom directed upward. Both wing tips showed impact damage but the left wing tip was more heavily damaged. The tail was also broken and twisted. The aircraft came to rest inverted. The hinges on the right passenger door were both broken. On the left door, the upper hinge was broken. (See Figure 5.) The region of the plane incorporating the foot well and the instrument panel was deformed upward at an almost 45 degree angle. (See Figure 6.) In addition, note that in this figure, the top of the instrument panel is at the ceiling of the plane.

Figure 4: This photograph shows the damage to the underside of the nose cone.

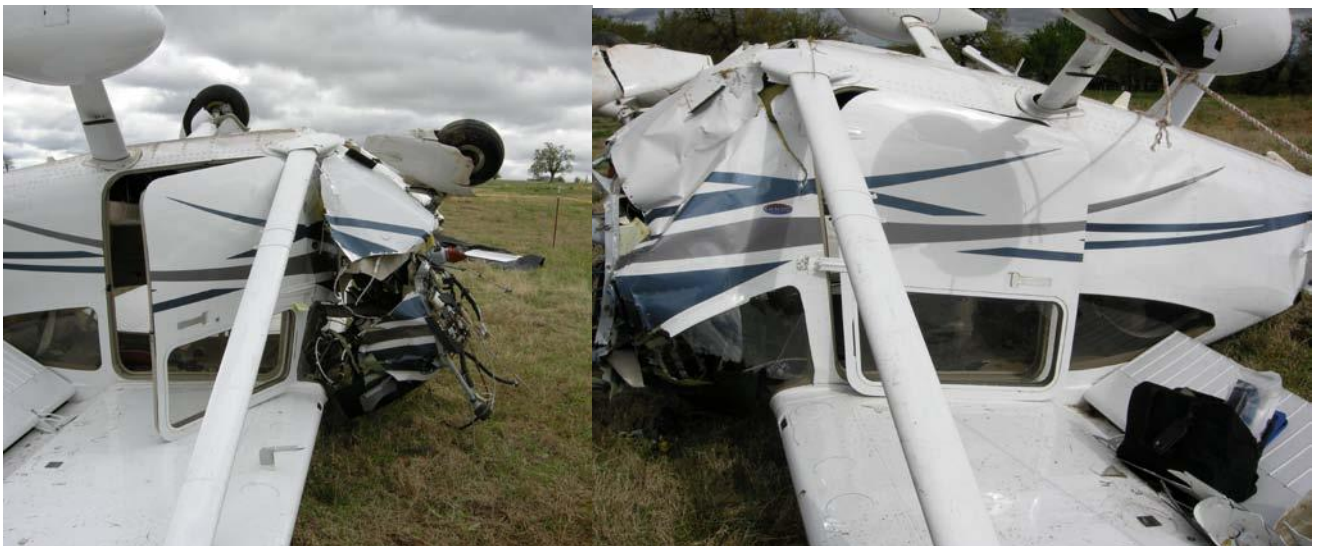
Figure 5: Photographs of the left and right side of the plane at final rest position.

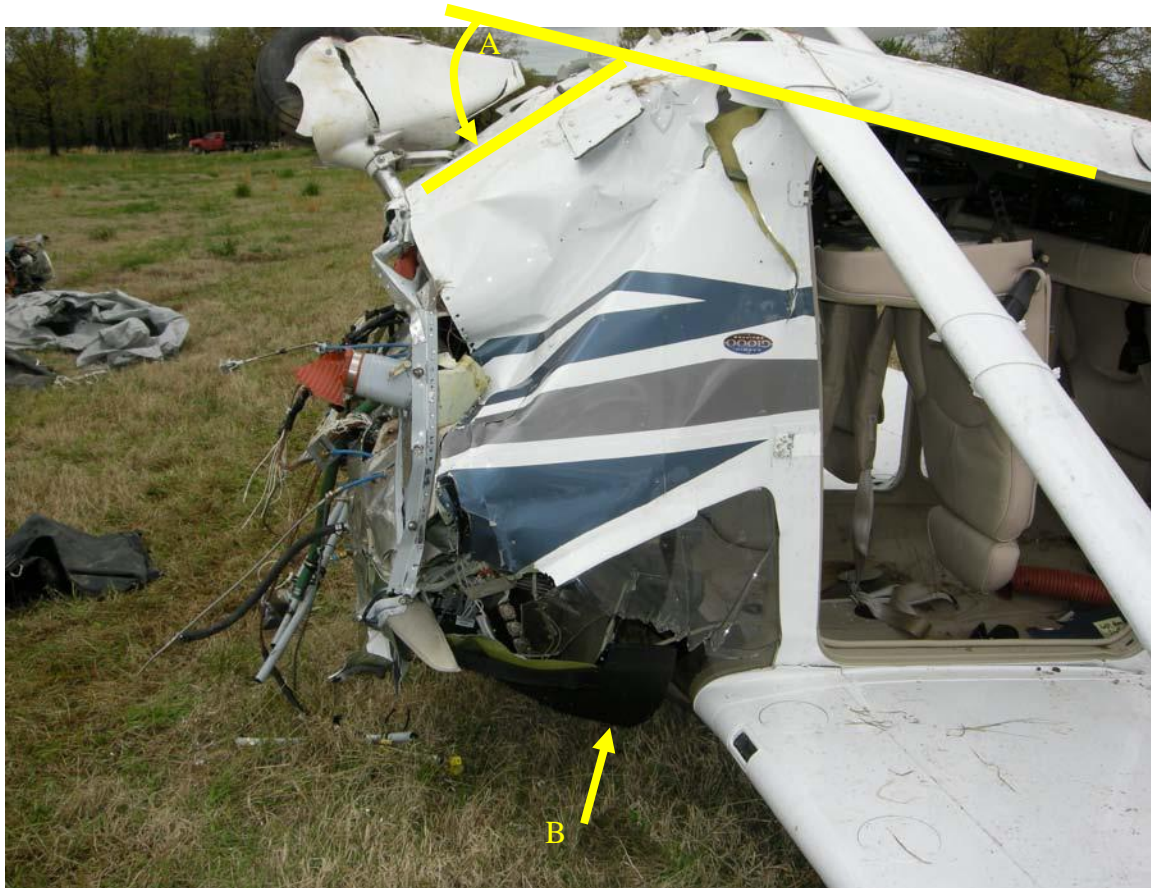
Figure 6: Damage to the front of the aircraft can be seen in this photograph looking at the right side of the aircraft. The region of the plane incorporating the foot well and the instrument panel (A) is deformed towards the roof of the airplane at an almost 45 degree angle. In addition, note that the top of the instrument panel is at the ceiling of the plane (B).

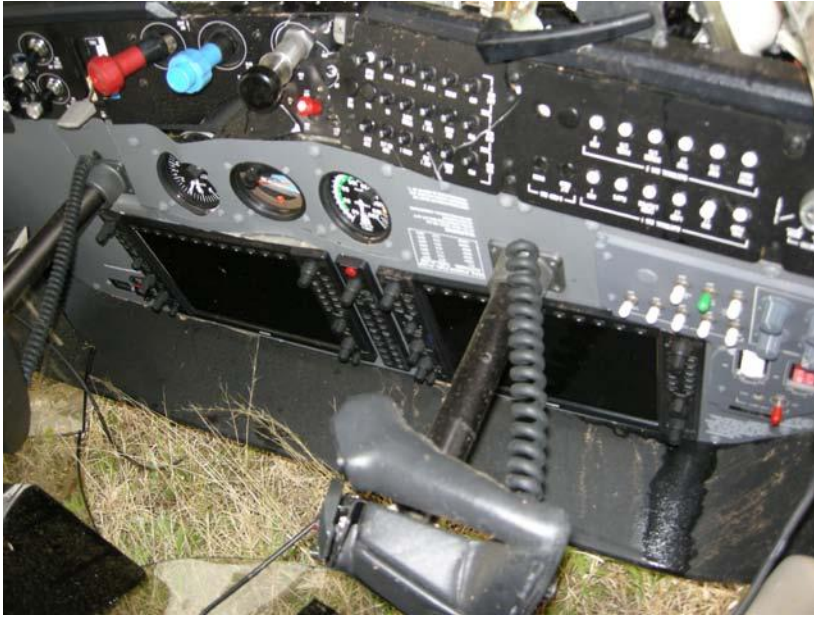
Figure 7: A photograph of the instrument panel and left control yoke at final rest position.

The deformation to the instrument panel was in and up. (See Figure 7 and Figure 8.) The glare shield and the instrument panel were rotated away from the occupants. The yokes and the top of the instrument panel were near the roof of the plane. Blood marks were noted on the roof predominately on the left (pilot's) side of the plane. The left glare shield was broken. The lower instrument panel was cracked and deformed inward in the

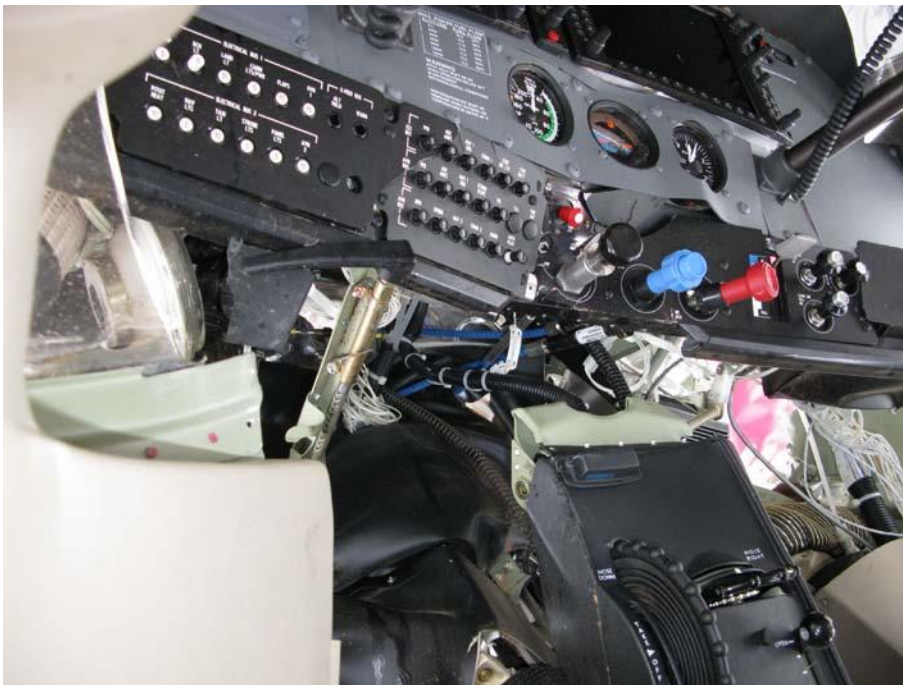
Figure 8: Another photograph showing damage to the instrument panel with the photograph rotated upwards.

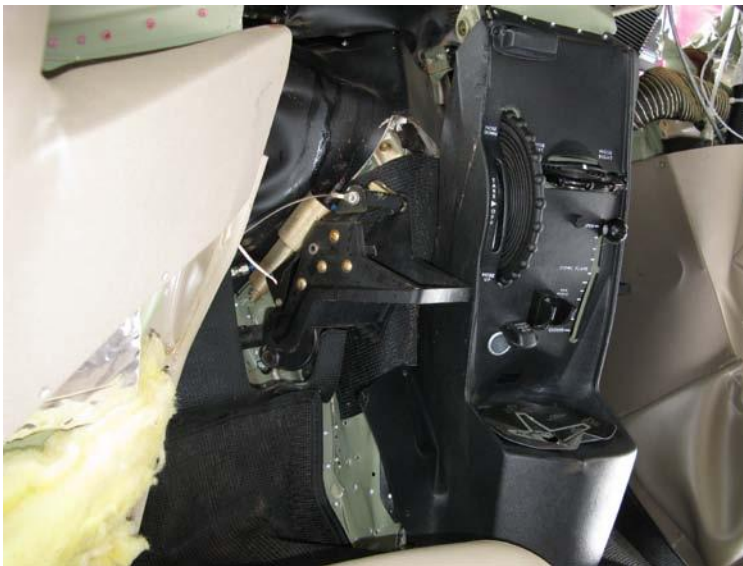
In order to document the displacement of the instrument panel, foot well region and the rudder pedals upward, (see Figure 9) the distance from the top of each rudder pedal to the front edge of the corresponding seat was documented (Table 1). Note that on the left side, the rudder pedals are at the height of the top of the seat pan whereas on the right side, they are below the top of the seat pan. In addition, on the left seat, the sidewall panel was compressed into the footwell/leg region. On the right side, the sidewall panel was essentially intact. For comparison, an exemplar photograph of a Cessna interior is shown in Figure 10.

Figure 9: A photograph showing the damage to the footwell region and rudder pedals on the pilot's side.

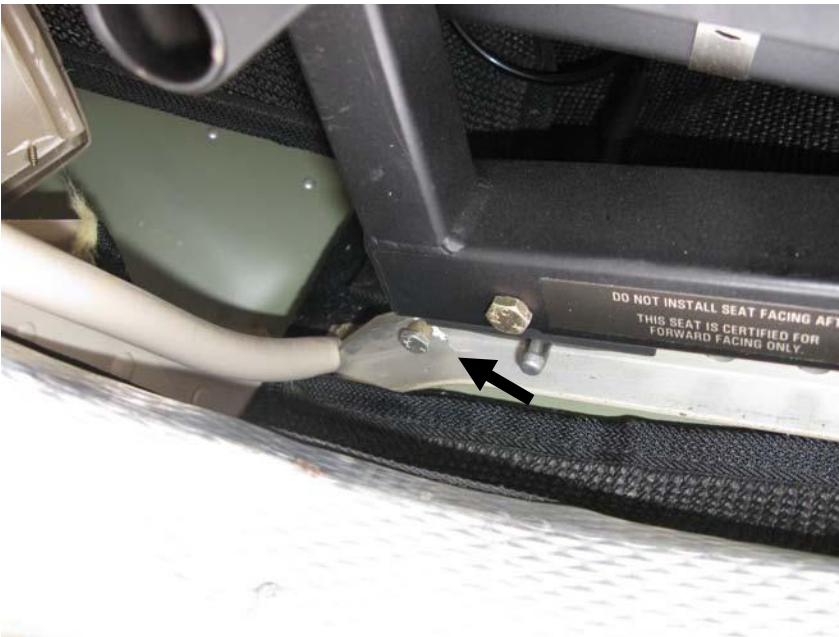
The pilot's seat was found in the 1st pin position (full forward). The passenger seat was in the 9th pin back from full forward. There were 14 total pin positions for each front seat. Damage was also noted to the front edge of the pilot's seat track and can be seen in Figure 11. General dimensions of the seats in the first row are shown in Figure 12. The seats are assembled by Cessna and are not specifically marked with any tracking numbers.

Figure 11: Damage to the front edge of the pilot's seat track.

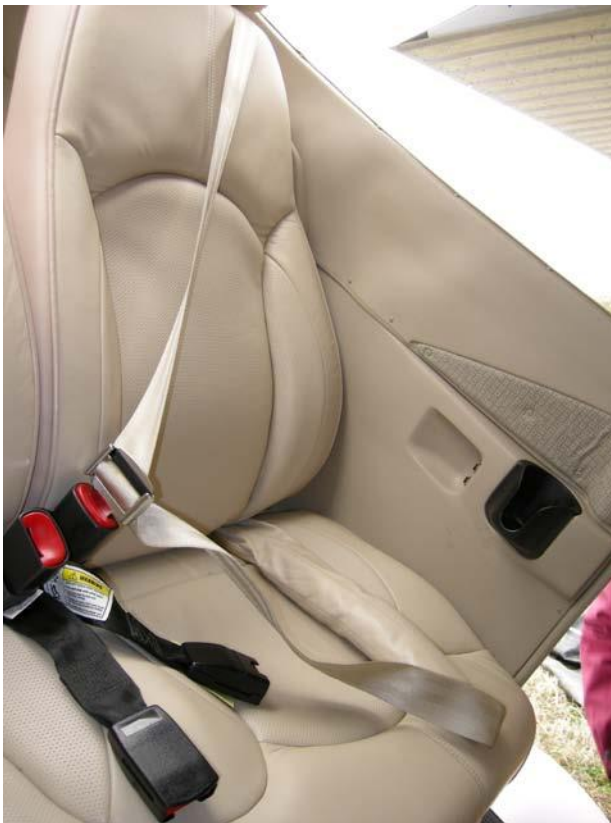
Both the left and right front seat restraint inertia reels were functional, post-accident but the webbing in the right front restraint would not fully retract into the reel. The inertia reels were functioning properly for the two rear seats. Prior to moving the accident aircraft, the restraint systems were examined to document latch position and potential load marks. The distance from the anchor bolt to the load bar for all four seat positions in the post accident position is detailed in Table 2. Note that for the rear seats, the anchor bolt was inaccessible, and therefore the cushion reference point, the point where the belt emerges from the cushion, was used as the reference for those measurements. Load marks were found under the load bar in all seating positions except the right, rear seat. The front seating positions exhibited heavier load marks than the left, rear seating position. The position of the belt on the left rear seat when the load bar was placed over the load marks is shown in Figure 17. The restraint identification numbers are shown in Figure 18.

Figure 17: The photograph shows the left rear seat with the restraint fastened in the post-accident position. Load marks were found under the load bar in this position.

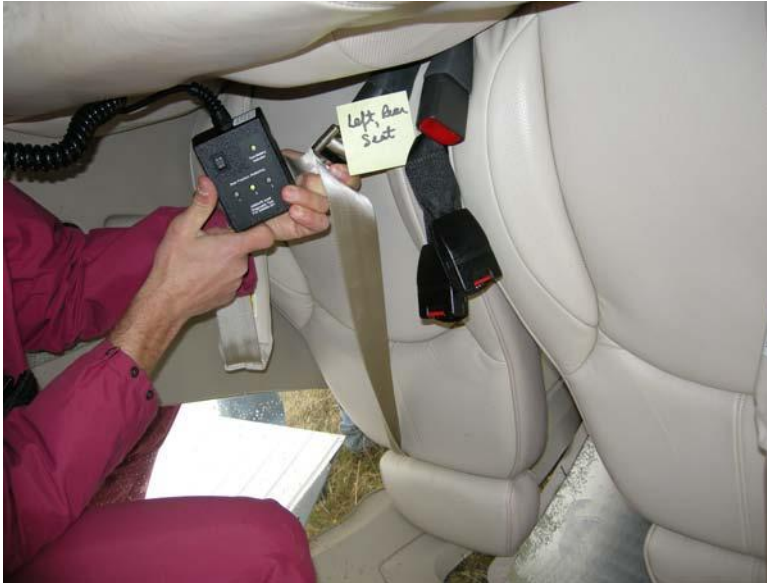
An AmSafe developed diagnostic test tool (P/N 508668-201) was used to assess the condition of the airbag system. The diagnostic tool was connected to each airbag system to assess whether the system was active and enabled. A green light indicates that the system is active and enabled. For all four airbags, the diagnostic tool showed a green light indicating that the system was active and enabled. (See Figure 19.) When the belt was fastened into the auxiliary child seat buckles, neither rear seat airbag was enabled. (See Figure 20.) In addition, in a previous investigation, it was noted that the front seat belts could potentially be switched such that the belt for the right seat occupant was actually used by the left seat occupant. This case was tested with the diagnostic tool and showed that the airbag system for the left seat occupant would still be active and enabled except that the airbag would have deployed from the unused belt.

Figure 19: This photograph shows the testing of the airbag system for the left, rear seat. The diagnostic tool shows a green light indicating that the airbag system was active and enabled. (Note that the airbag systems were examined prior to moving the aircraft from its final rest position.)

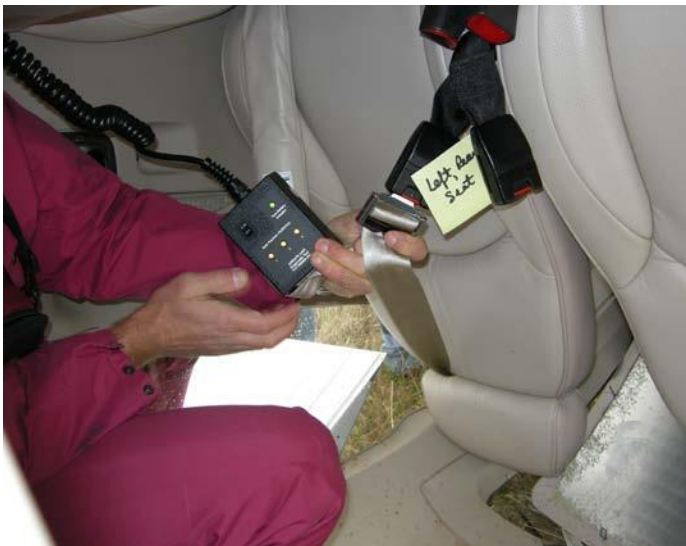
Figure 20: This photograph shows the testing of the airbag system for the left, rear seat using the auxiliary child seat buckles. The diagnostic tool shows three orange lights indicating that the airbag system was not active or enabled. (Note that the airbag systems were examined prior to moving the aircraft from its final rest position.)

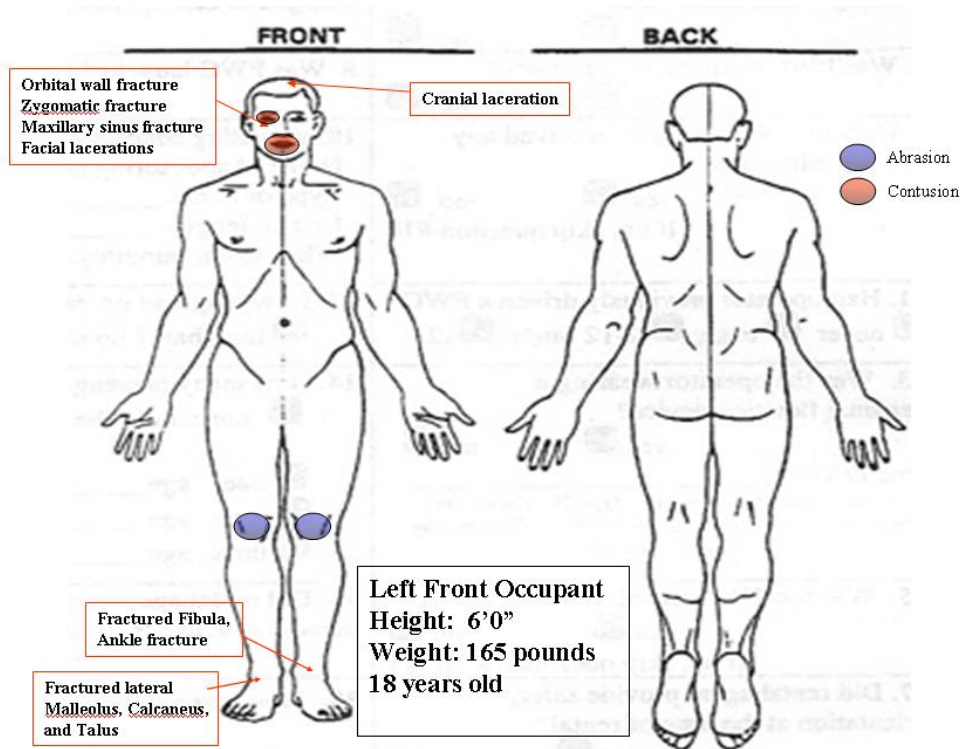
Occupant Location	Gender	Age	Height	Weight	Description Of Injuries	Injury Classification
1 st Row, Left	M	18	6'0"	165 lbs	Left fibula fracture, non-displaced left ankle fracture, right lateral malleolus fracture, non-displaced right calcaneus and talus fracture, right orbital wall fracture, right zygomatic fracture, right maxillary sinus fracture, facial lacerations, right eye contusion, upper and lower lip contusion, bilateral knee abrasions	Serious
1 st Row, Right	F	43	5'3"	125 lbs	Contusions on left shoulder and left side of neck, contusions and abrasions on right hip	Minor
2 nd Row, Left	F	45	5'6"	162 lbs	Left knee contusion, anterior left ankle laceration	Minor

Figure 22: A diagram showing the injury locations for the pilot.

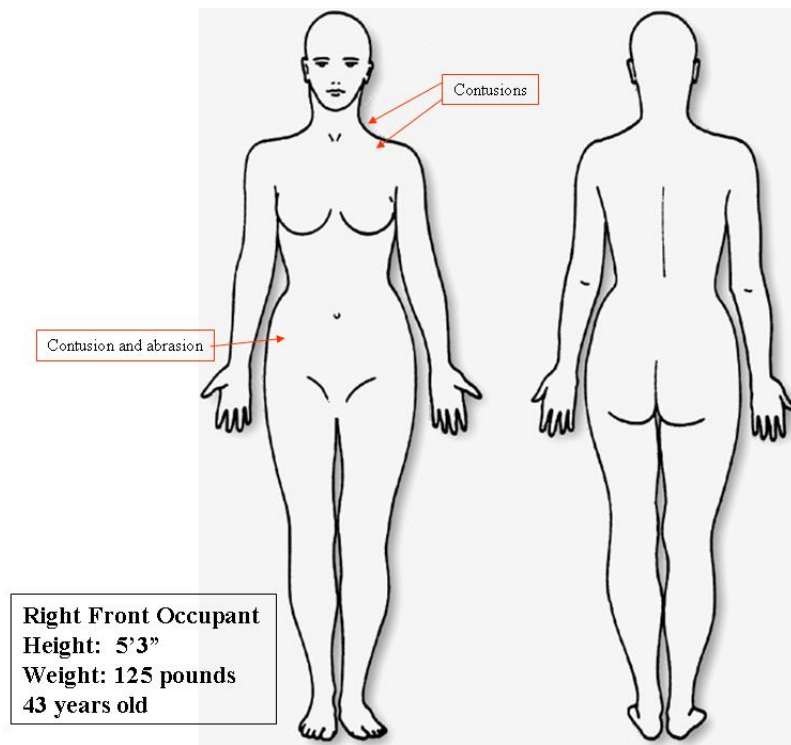
Figure 23: A diagram showing the injury locations for the right front occupant.

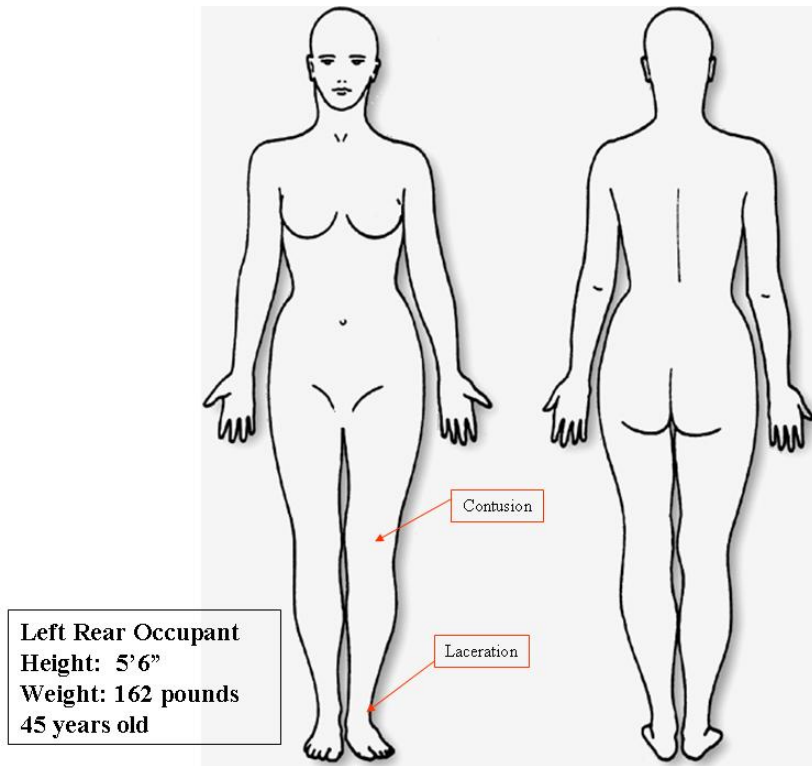
Figure 24: A diagram showing the injury locations for the Left rear occupant.
